Research article

Bioremediation of mortar made from Ordinary Portland Cement degraded by *Thiobacillus thioeparus* using *Bacillus flexus*

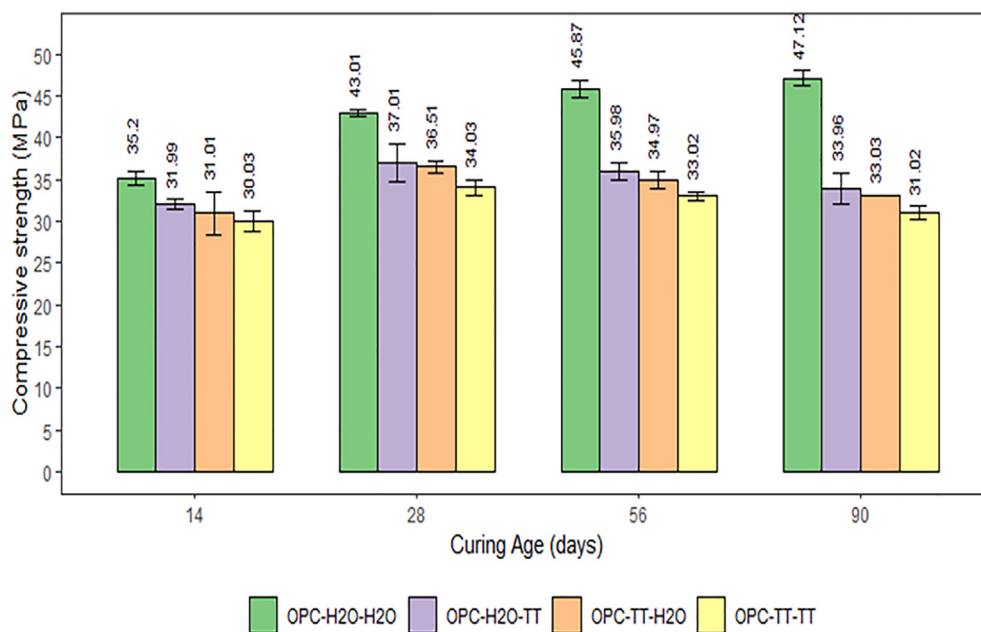
**Figure 1.** Compressive strength with varied curing age.

Figure 1 represents results of compressive strength of the control and microbial mortars. The compressive strength of the control mortars, OPC-H₂O-H₂O, was noted to have improved with curing period with the highest noted at 90th day as 47.12 MPa. This was attributed to the continued hydration reactions with curing period [17]. However, the strength did not increase appreciably after 28 days of curing. This was attributed to slow cement hydration process since OPC gains much of its strength by 28th day of curing [17]. Ngari et al. [24] and Muthengia et al. [25] made similar observations. They attributed the same to early hydration reactions of OPC (by 28th day of curing). It was observed that the microbial mortars compressive strength was below that of the control mortars across all the categories. This was supported by SEM images Figures 3 and 5, from 3 and 5, CSH is observed and it is the cement hydration product majorly responsible for cement strength development

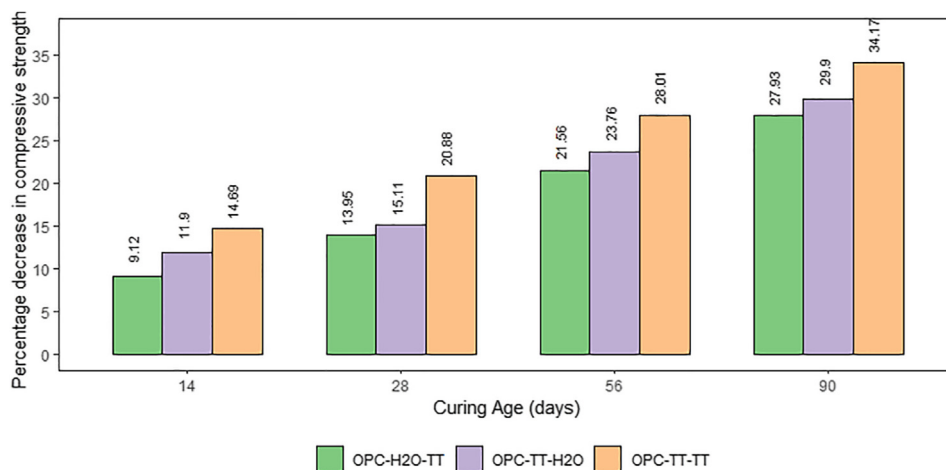
Figure 2. Percentage decrease in Compressive strength with curing Age.

[19]. However, this was missing in the biodegraded mortar, Figure 4. From Figure 2, it is clear that the highest percentage decrease in compressive strength was recorded at 90 days of curing as 34.17 % for OPC-TT-TT category of mortars. This perhaps was due to the degradation effect of *Thiobacillus thioparus* increased with duration of curing. This could further show that, deleterious effect was influenced by the mix media during prism casting. Additionally, the most affected mortars were OPC-TT-TT category and the least affected were the OPC-H₂O-TT category. This was attributed to the deleterious/deterioration effect of *Thiobacillus thioparus*. This was expected due to MID process by *Thiobacillus thioparus* [4, 26]. The bacterium being a sulphur oxidizing bacteria degraded the mortars.

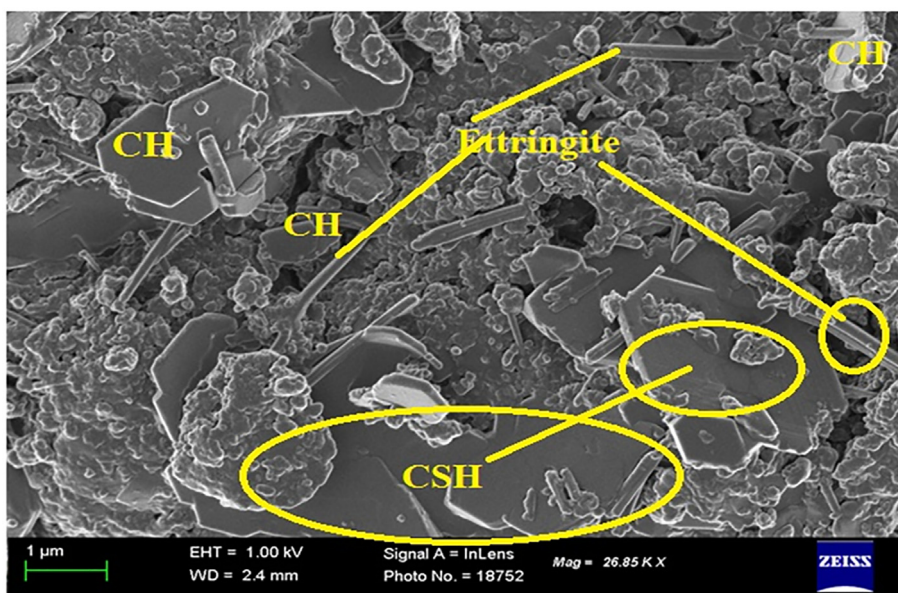
Figure 3. SEM micrograph for control mortar, OPC-H₂O-H₂O.

The SEM images for OPC-H₂O-H₂O, OPC-TT-TT and OPC-TT-BF are given in Figures 3, 4 and 5 respectively. For the control sample, ettringite was seen as needle - shaped crystals. This ettringite was the hydration product formed when tricalcium aluminate complexes with gypsum. The gypsum added to give cement the desired setting qualities [17]. Tricalcium aluminate reacts faster with water compared to tricalcium silicate

respectively. The hydration products perhaps sealed the pores and the calcite formed from MICP process possibly sealed the pores and micro-cracks as is evident from the SEM image, Figure 3. *Bacillus flexus* being a calcite precipitating bacteria precipitated calcite that deposited in the pores and in the micro-cracks/voids. Figure 3 shows massive biodeposition of calcite. It was further noted that after 96 h the increase in water absorption was not very appreciable for both the control and bacterial mortars. At this time, saturation of mortars perhaps could have reduced capillary suction.

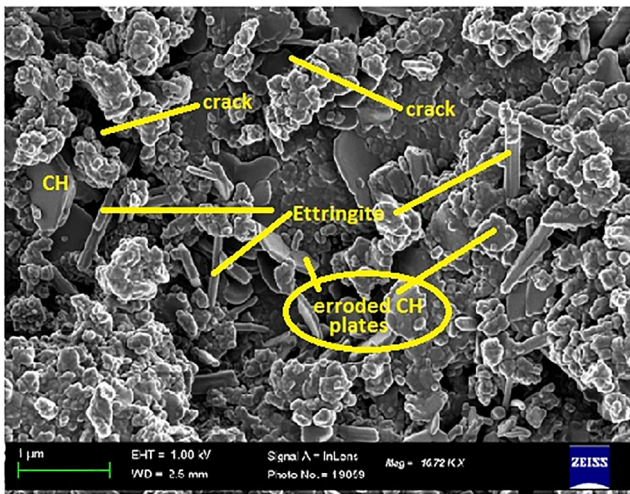
Figure 4. SEM image for the biodegraded mortar, OPC-TT-TT.

and that would result in flash setting [18]. Sulphate added complexes with tricalcium aluminate to give ettringite. This ettringite passivates aluminate crystals and is formed as given Eq. (5) [17]. From the SEM image for OPC-TT-TT, massive deposits of ettringite are observed, eroded calcium hydroxide (CH) plates and micro-cracks. These were perhaps due to the metabolic activity of *Thiobacillus thio-parus* which is a deleterious bacterium. Sulphur oxidizing bacteria have been documented to develop biogenic sulphuric acid in the sewer system [19, 20]. *Thiobacillus thio-parus* bacteria being a sulphur oxidizing bacteria, oxidized hydrogen sulphide gas to produce the same acid. This acid attacks the CH and C-S-H, which are major products of cement hydration reaction to produce gypsum which in turn reacted with tricalcium aluminate phase of cement to give secondary ettringite [21]. These reactions are given in Eqs 5, 6, 7:

The observed micro-cracks/voids were due to excessive internal pressure that resulted from gypsum and ettringite formed as shown in Eqs. (5) and (7) [2]. This exposed the mortar to possible degradation as these micro-cracks act as pathways (since they are inter-linked/interconnected) for aggressive agents' ingress. Micro cracking of cement made material was reported by Joshi *et al.* [22]. They [22] attributed this to the buildup of gypsum and ettringite within the pore system of the cement matrix. Meas and De Belie [23] made similar observation. From Figure 4, massive destruction of the cement mortar matrix was observed in the microbial mortars involving *Thiobacillus thio-parus*. The observed eroded CH plates were due to the aggressive effect of the biogenic sulphuric acid. The bacteria have been found to attack new cement made pipe surfaces [5]. This results in production of hydrogen sulphide gas has been identified as the major deleterious agent in both sewer and waste water treatment systems [7]. This is due to formation of biogenic sulphuric acid which is considered to be responsible for the degradation [7]. Muthengia *et al.* [3], associated cracking and spalling of mortar matrix to the expansive gypsum and ettringite. This has been demonstrated in Eqs. (2) and (3). OPC-TT-BF micrograph show ettringite and micro-cracks/voids undergoing healing by *Bacillus flexus*. Calcite formed from MICP process is deposited during the healing process.

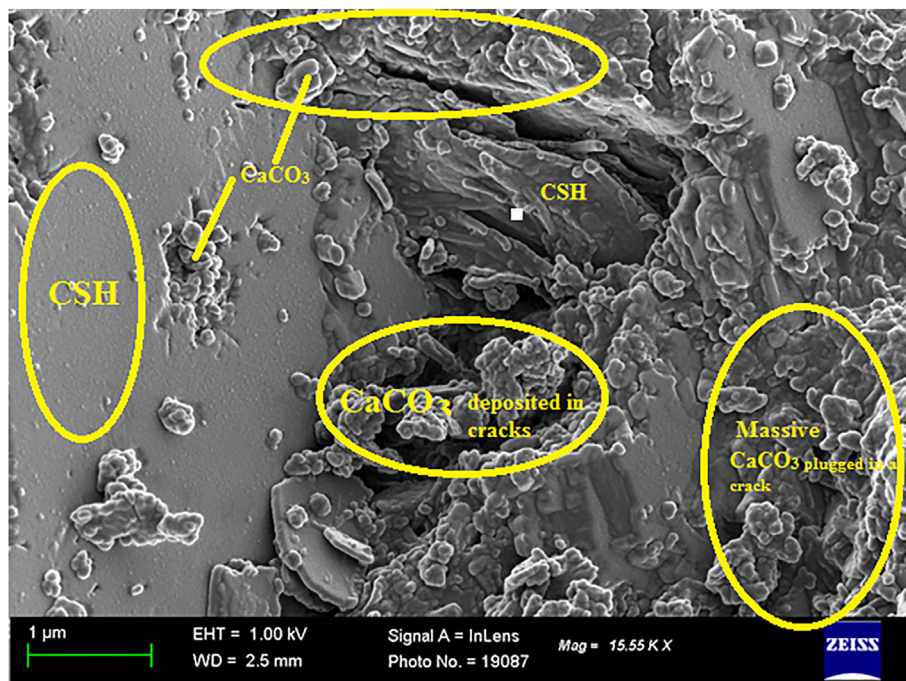
Figure 5. SEM image for bioremediated mortar, OPC-TT-BF.

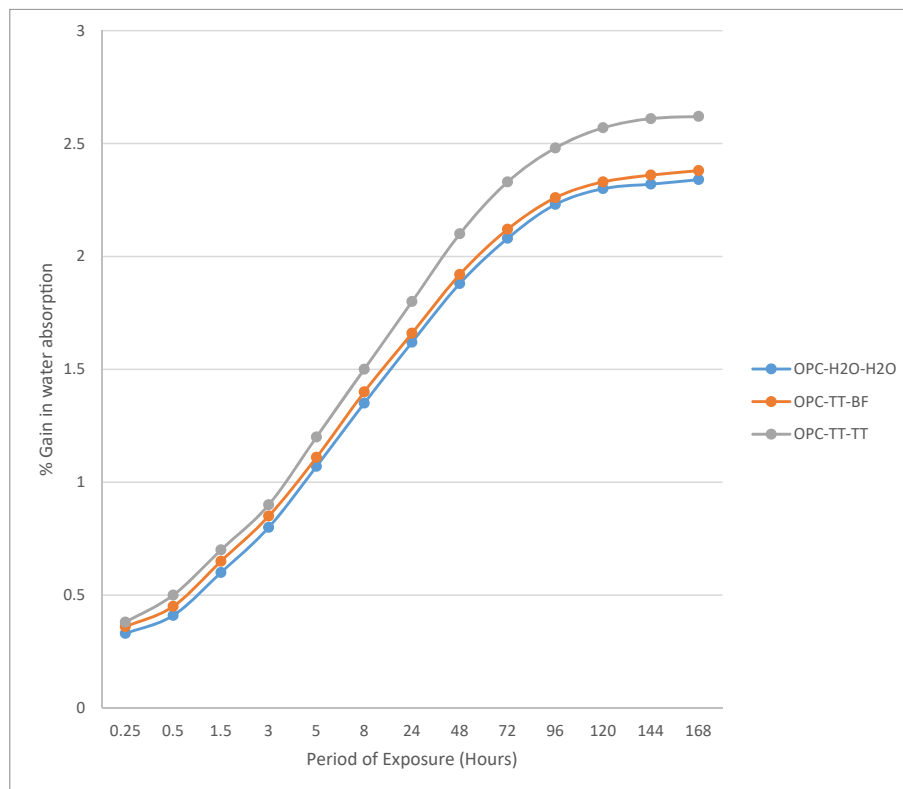
Figure 6. % Gain in water absorption.

Water absorption tests were carried up to 168th hour and the findings presented in Figure 6. From the findings, OPC - TT -TT exhibited the higher percent gain in water absorption as compared with the control and the remediated mortars, OPC-H₂O-H₂O and OPC-TT-BF respectively. This could perhaps be due to massive deterioration of the cement mortar matrix by *Thiobacillus thio-parus*. This deterioration resulted in formation of multiple micro-cracks which made the mortar extensively porous. The porous material increased the absorption of water. This observation was similar to Munyao *et al.* [2] findings. Lower gain in percent water absorption observed with the control and remediated mortar prisms was attributed to a denser microstructure due to continued hydration reactions and MICP process
